# SEM study of the weathering effects on painted wood

*Izvorni znanstveni rad - Original scientific paper*

This study is a part of the EU/AIR-project 'Performance and durability of wooden window joinery painted with new types of paints with low organic solvent content' (AIR3-CT94-2463, DG XII). The preparation, exposure and tensile testing of the thin strips were carried out at The Centre for Timber Technology and Construction, Building Research Establishment Ltd, Watford (UK). The preparation and exposure of the panels, as well as the SEM work, were performed at the Wood Department of the Swiss Federal Laboratories for Materials Testing and Research (EMPA), Dübendorf, Switzerland. The work was carried out within a programme of co-operation between EMPA and the Faculty of Forestry, Zagreb University, Croatia.

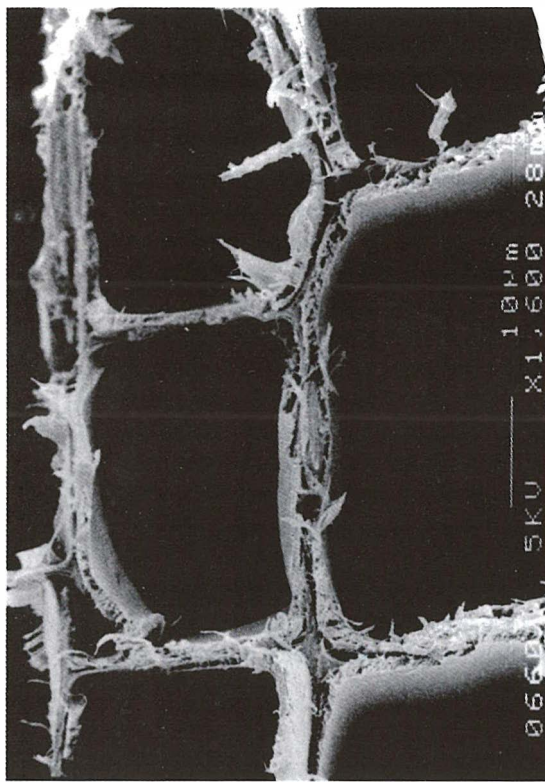
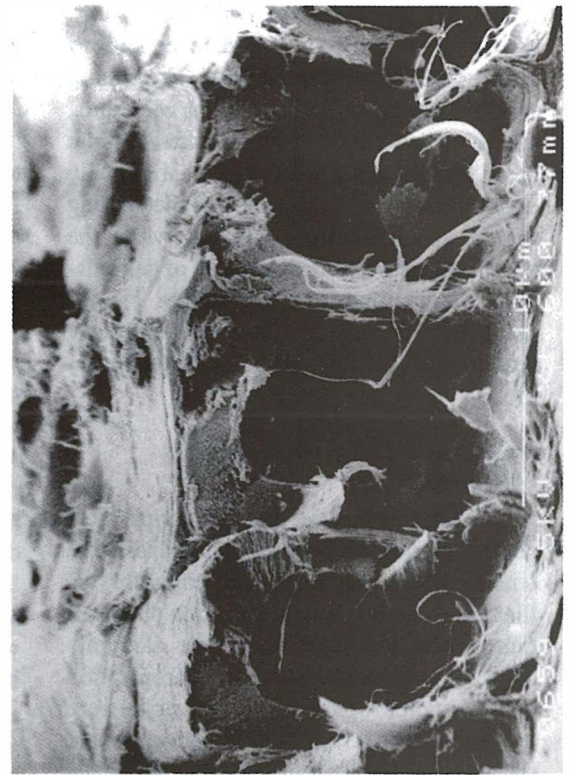
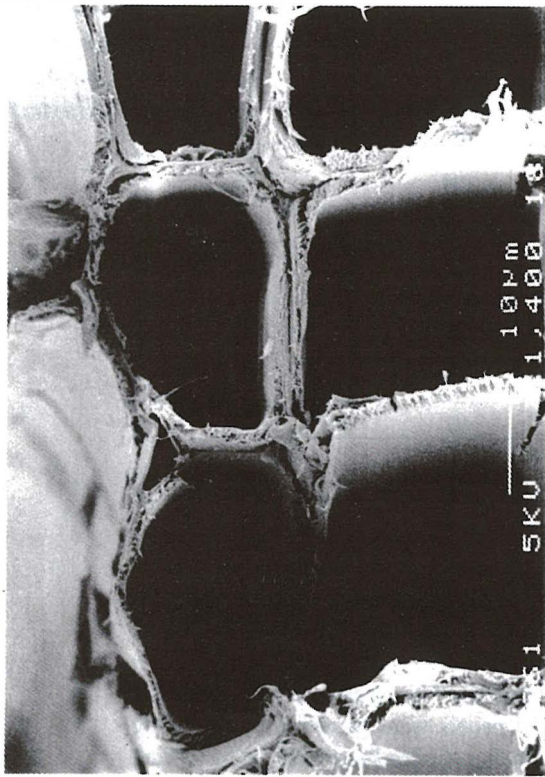
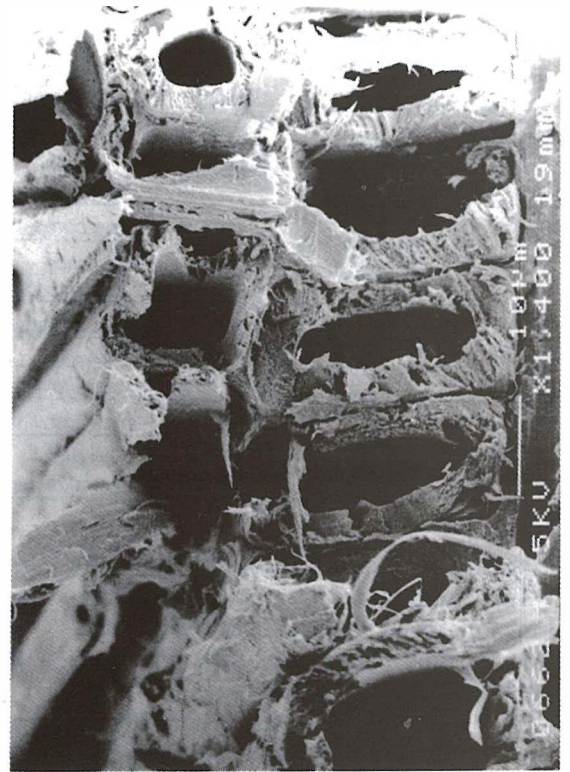
Fig. 1 - 4:

Fractured transverse surfaces of unexposed thin wood strips (dry-tested, 10 mm span): Pine latewood (Fig. 1), pine earlywood (Fig. 2), spruce earlywood (Fig. 3), and spruce latewood (Fig. 4). ● Slike 1 - 4: Poprečne lomne površine nezložjenih tankih listića (ispitanih suho na 10 mm rasponu): bjeljika borovine (sl. 1), srževina borovine (sl. 2), rano drvo smrekovine (sl. 3) i kasno drvo smrekovine (sl. 4).

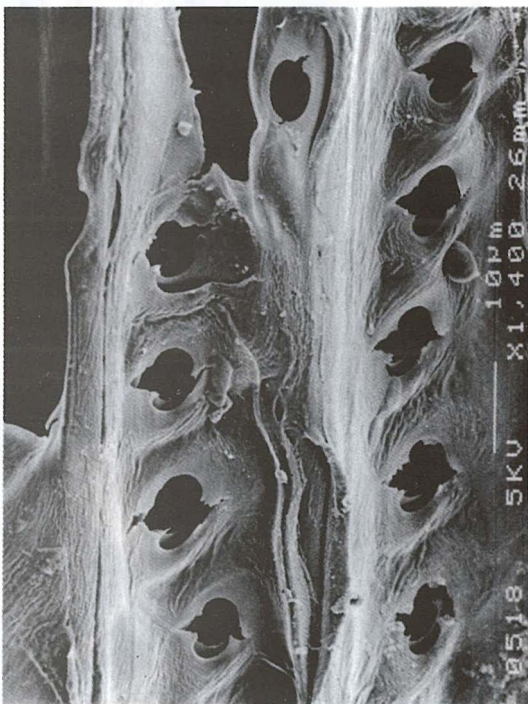
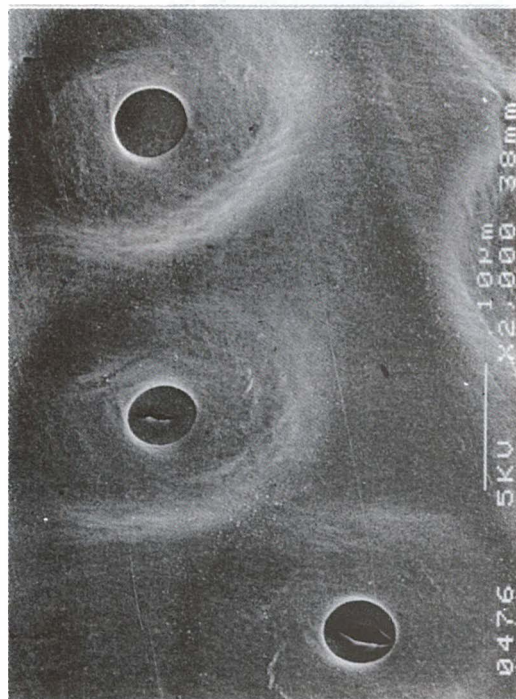
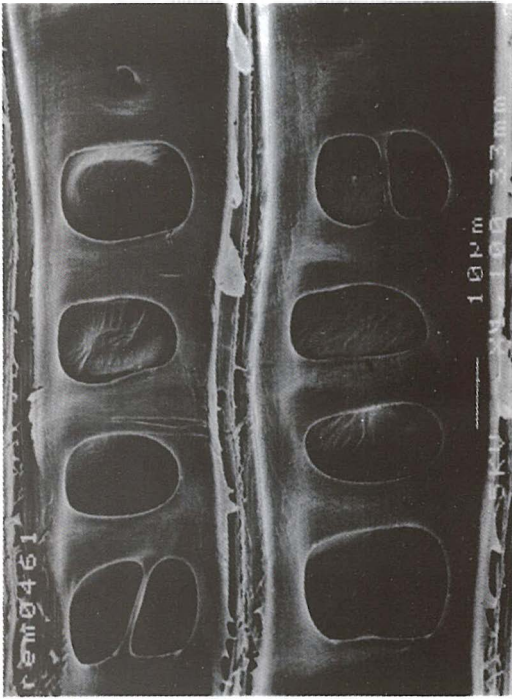
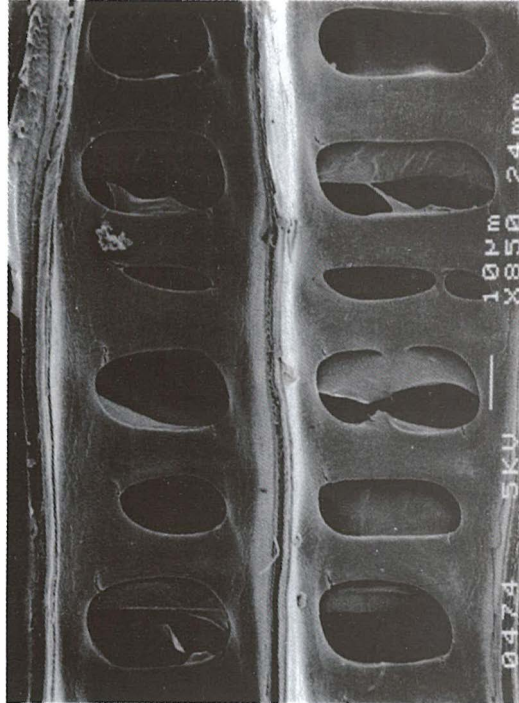
Fig. 5 - 8:

Radial surfaces of thin pine strips exposed naturally for 12 weeks without a coating (Fig. 5) and behind a detached film of the solvent-borne stain (Fig. 6 - 8): Occasional damage on bordered pits (Fig. 6) or on fenestriform pitting (without damage in Fig. 7 and slightly damaged in Fig. 8) is recorded on the rear faces of the strips which is probably caused by the UV light reflected from the mounting panel. Slike 5 - 8: Radijalne površine tankih listića borovine koja je bila prirodno izložena 12 mjeseci bez zaštitnog filma (sl. 5) i iza slobodnog filma organske lazure (sl. 6 - 8): mjestimična oštećenja ogradenih jazica (sl. 6) ili fenestriformnog ožučavanja (bez oštećenja na sl. 7 i sa neznatnim oštećenjem na sl. 8) se mogu vidjeti na stražnjim ploham listića što je vjerojatno prouzročeno UV svjetlom koje se odbijalo od nosive plohe.

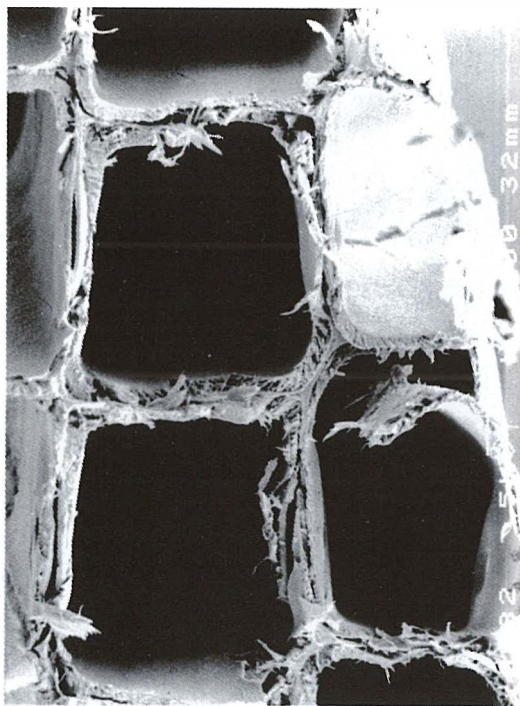
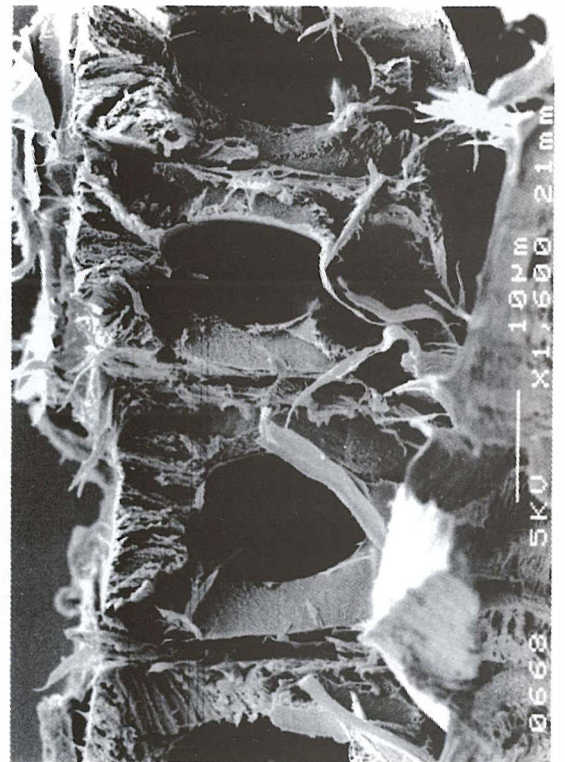
Fractured transverse surfaces of thin strips exposed naturally for 12 weeks: Pine earlywood behind a detached film of a stain (Fig. 9) and spruce latewood behind a detached film of an opaque paint (Fig. 10) show no changes in the mode of failure in comparison with unexposed strips (Fig. 1 - 4). Unprotected pine earlywood (Fig. 11) and pine latewood (Fig. 12) show development of biological growth (Fig. 11) and brittleness (Fig. 12).

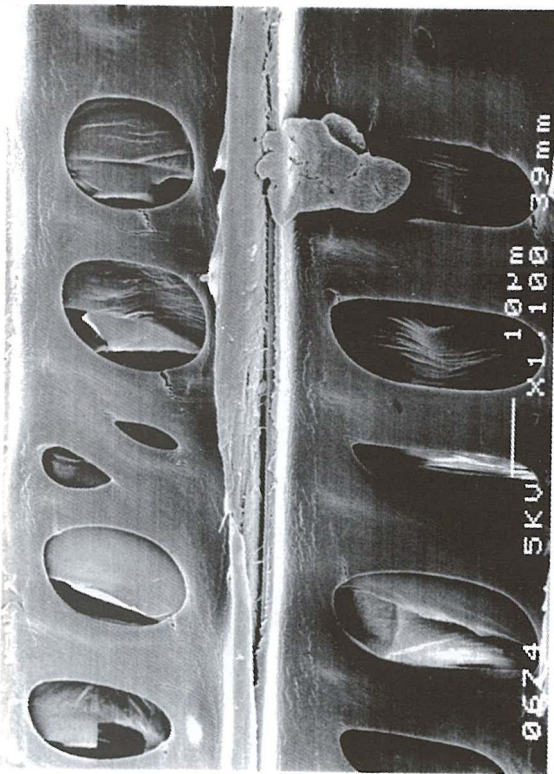
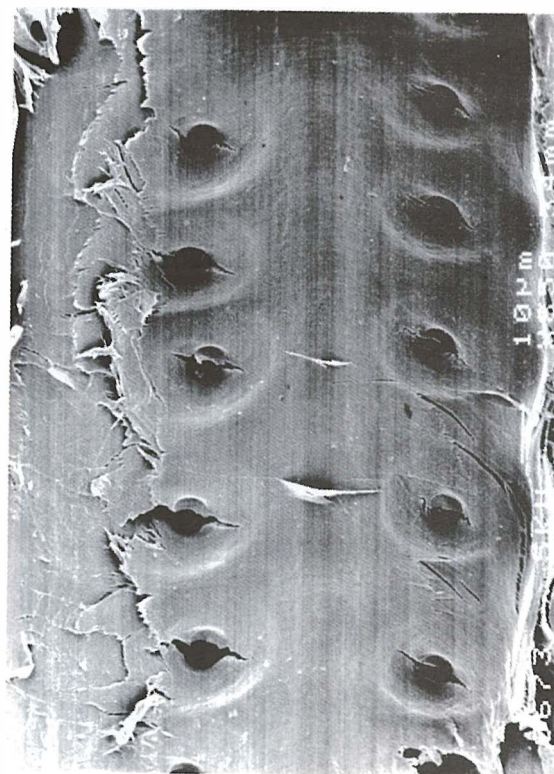
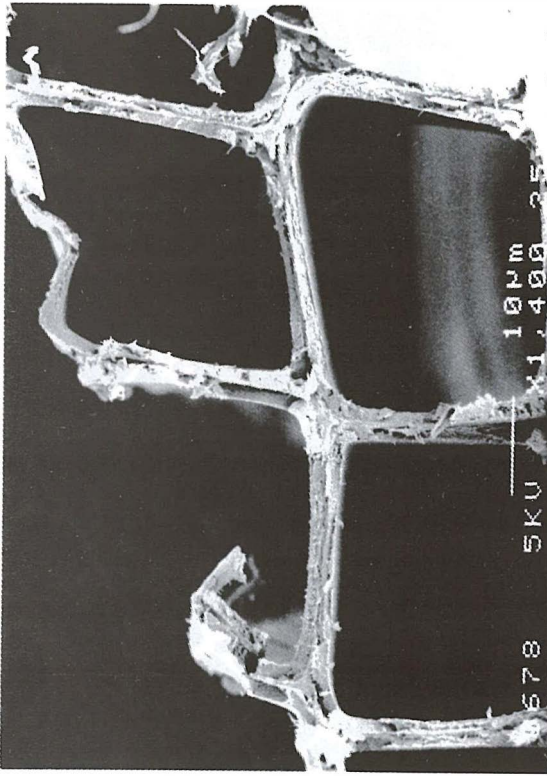
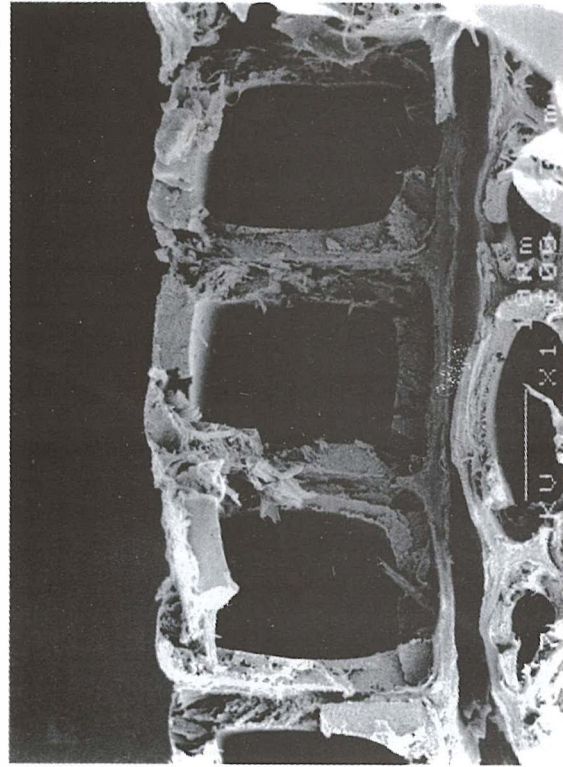
Fig. 13 - 16:

Condition of thin strips exposed artificially in the QUV for 14 weeks behind a detached film of the solvent-borne stain (Fig. 13) and bordered pits of pine (Fig. 14) show characteristic damage from the effect of UV light. The tension-loaded cross sections of spruce earlywood (Fig. 15) and latewood (Fig. 16) exhibit typical brittle fracture due to light-induced delignification. • Slike 13 - 16: Stanje tankih listića koji su bili izloženi 14 tjedana izloženi u uređaju za laboratorijsko klimatsko izlaganje QUV. Listići su bili izloženi iza slobodnog filma lazure s organskim otapalima: Fenestriformne jačice polja ukrštavanja (sl. 13) ograđene jačice borovine (sl. 14) pokazuju karakteristična oštećenja uslijed djelovanja UV svjetla. Poprčne lomne površine vlačno potrganih listića ranog drva smrekovine (sl. 15) kasnog drva smrekovine (sl. 16) pokazuju tipični kri lom koji nastaje zbog svjetlom ujetovane delignifikacije.

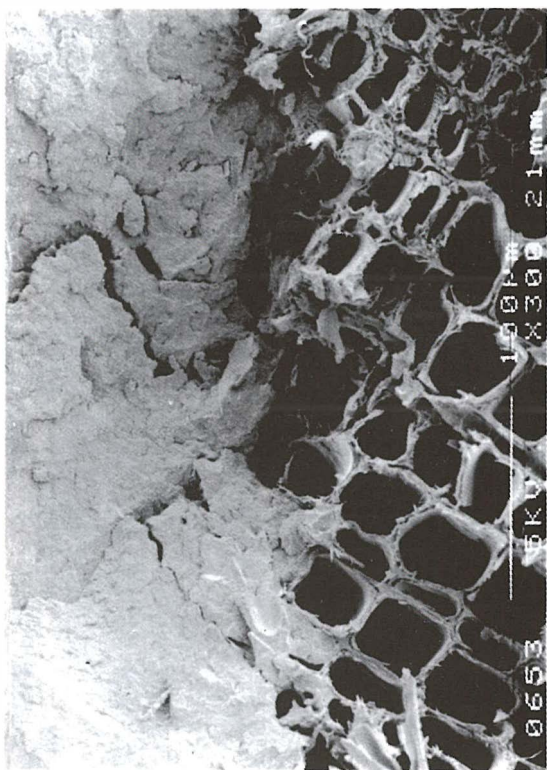
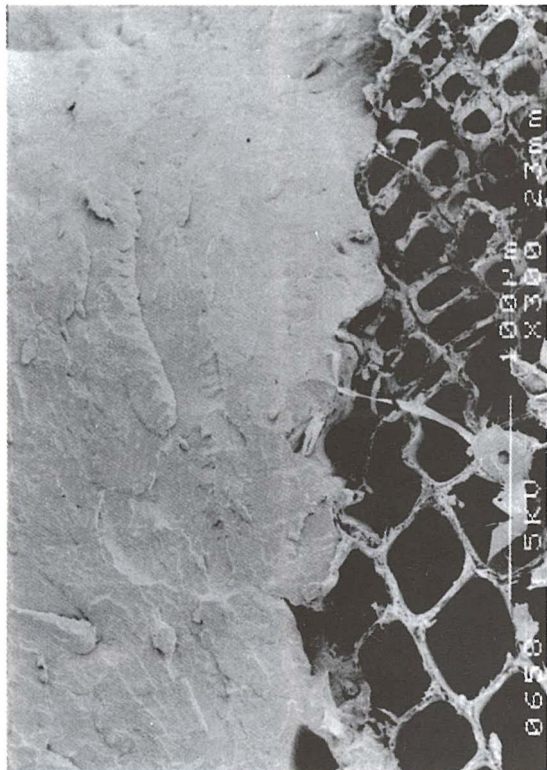
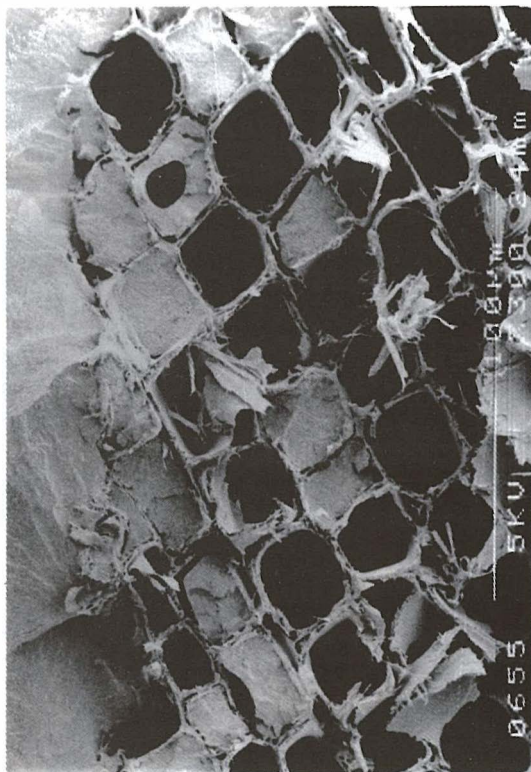
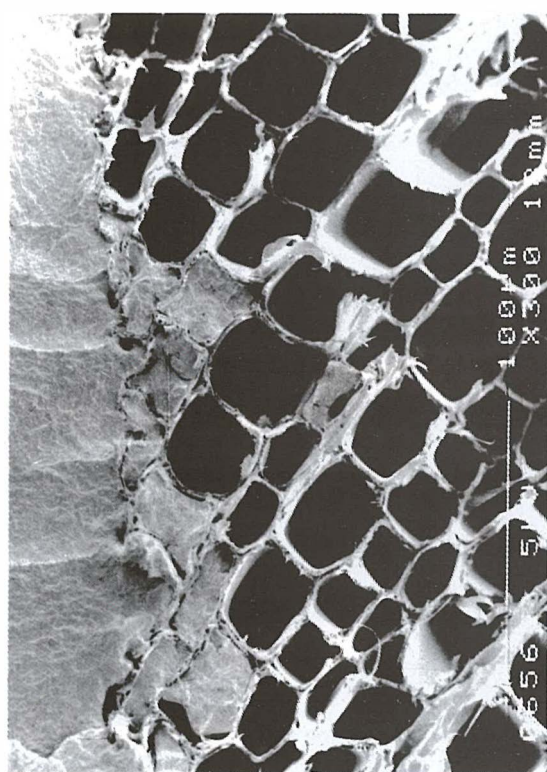
Fig. 17 - 20:

Fractured transverse surfaces of tension-loaded bending specimens from 'unexposed' coated pine panels: Water-borne opaque paint (Fig. 17), water-borne semi-transparent stain (Fig. 18), solvent-borne opaque paint (Fig. 19) and solvent-borne semi-transparent stain (Fig. 20): Poprečne lomne površine vlačnih zona uzoraka potrganih savijanjem: ovo su "neizložene" plohe površinski obraðenih borovih dasčica. Vodotopljivi neprozirni nalič (sl. 17), vodotopljiva poluprozirna lazura (sl. 18), organski neprozirni nalič (sl. 19) i organska poluprozirna lazura (sl. 20).

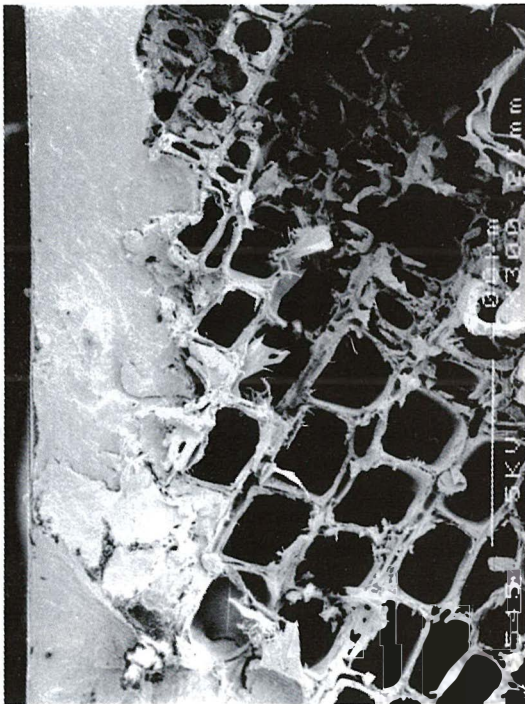
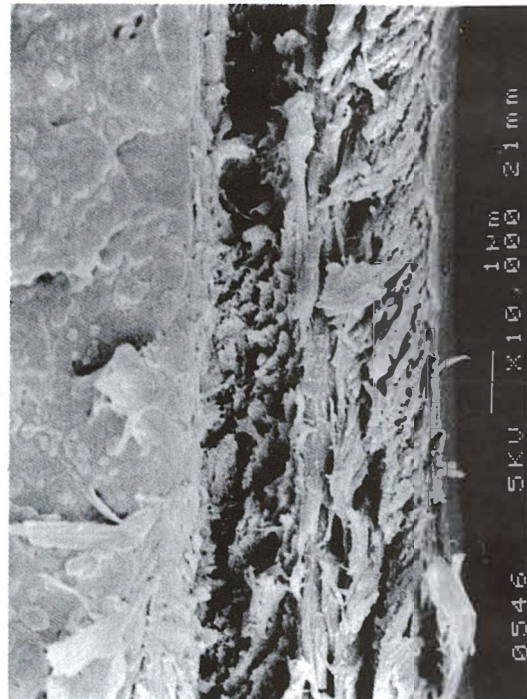
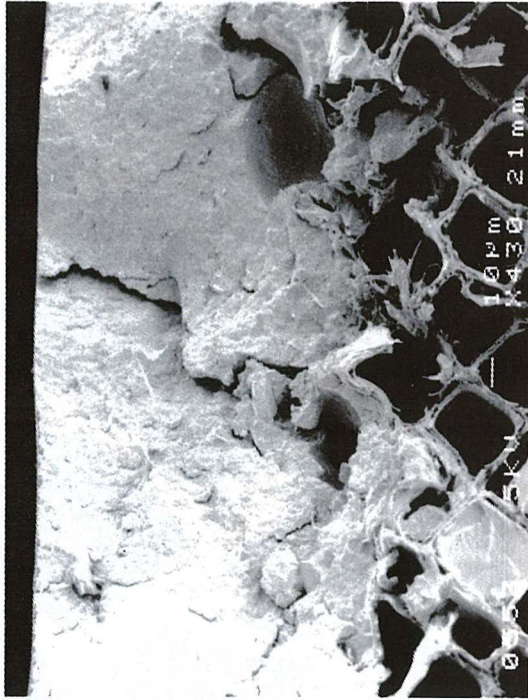
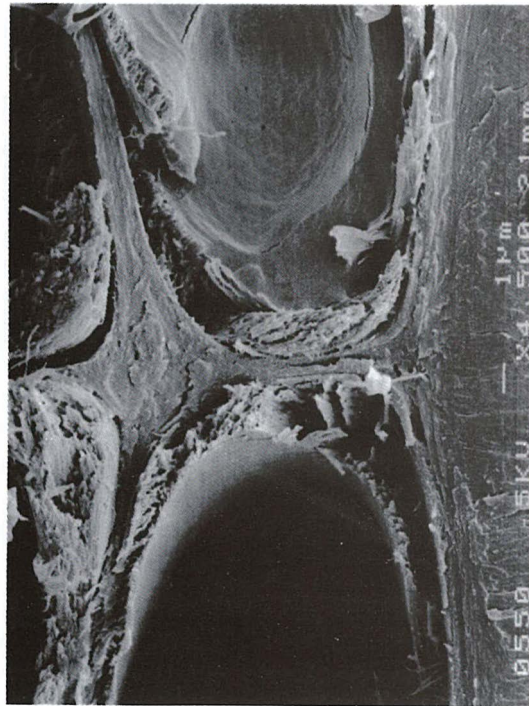
Fig. 21 - 24:

Fractured transverse surfaces of tension-loaded bending specimens from pine panels coated with solvent-borne (Fig. 21 - 22) or water-borne opaque paint (Fig. 23 - 24) after 14 months of natural exposure: The higher magnification reveals good adhesion of both paints to the S3 layer but no penetration into the cell wall.

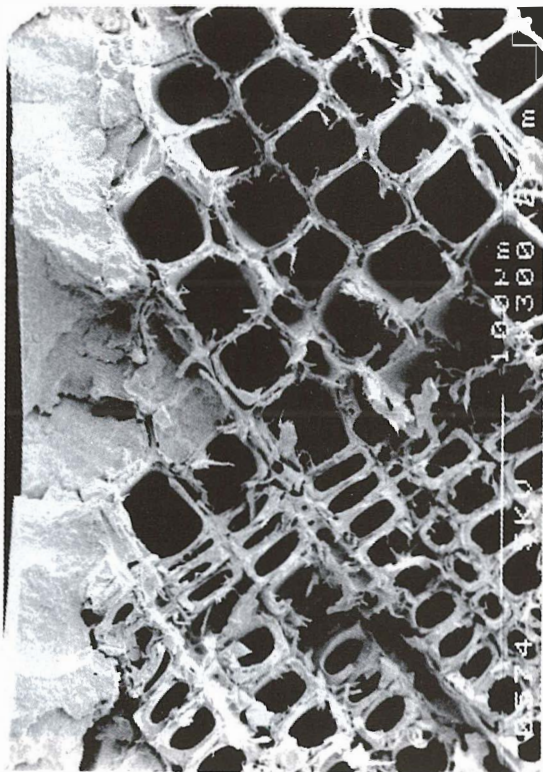
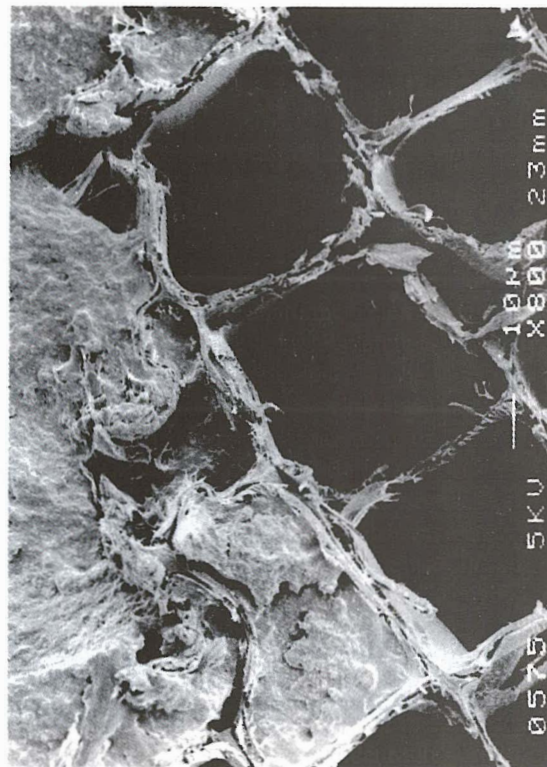
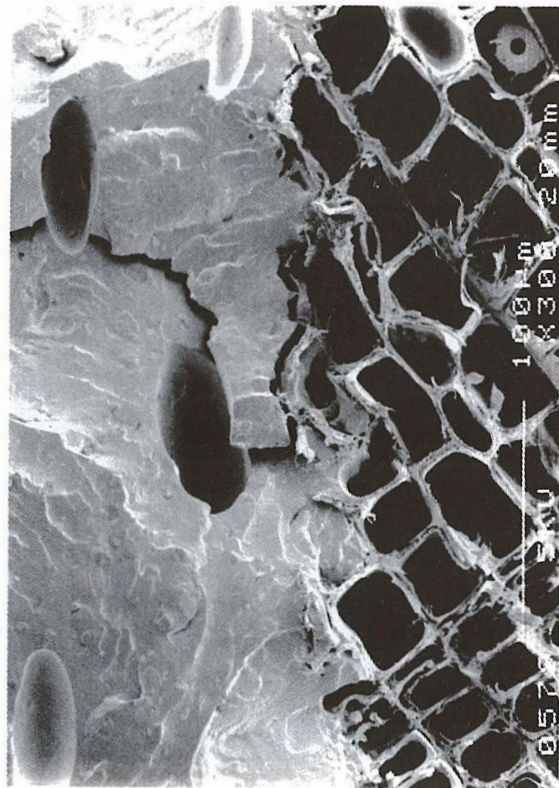
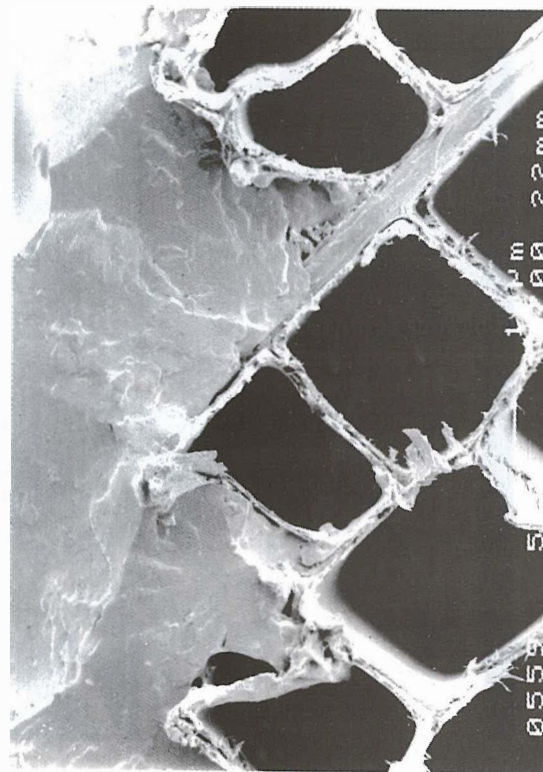
Fig. 25 - 28:

Fractured transverse surfaces of tension-loaded bending specimens from pine panels coated with solvent-borne (Fig. 25 - 26) or water-borne stain (Fig. 27 - 28) after 14 months of natural exposure. • Slike 25 - 28: Poprečne lomne površine vlačnih zona potrganih savijanjem. Ovo su izravno izložene plohe borovih dasčica obrađanih organskom (sl. 25 i 26) ili vodotopljivom lazurom (sl. 27 i 28) nakon 14 mjeseci prirodnog izlaganja

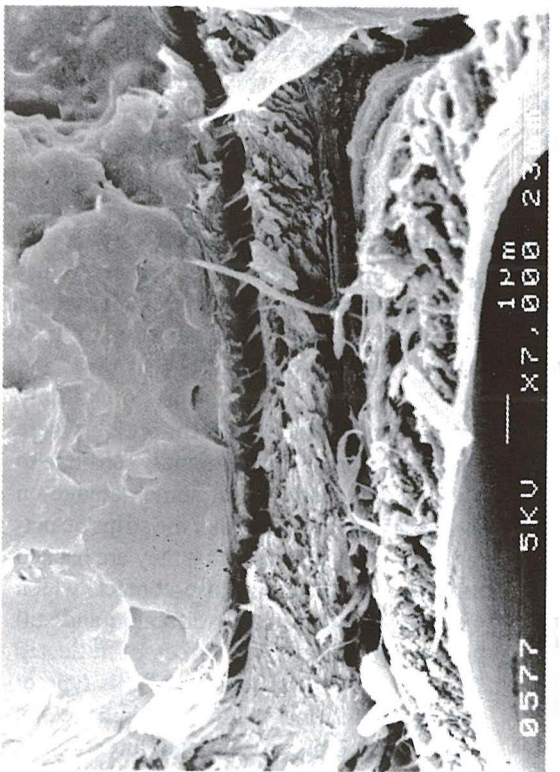
Fig. 29

A larger magnification of the cross sections from the pine panels coated with stains (Fig. 25 - 28) shows cases of delamination: The solvent-borne stain was observed to fail through separation from the cell wall (Fig. 29) or by the cohesive failure of UV light-damaged wood (Fig. 30) or by a combination of the two (Fig. 31). The water-borne stain only very rarely exhibits lack of adhesion to the substrate (Fig. 32). • Slike 29 - 32: Veća povećanja poprečnih presjeka uzorka od borovih dasčica obrađenih lazurama (sl. 25 - 28) iskazuju delaminaciju; primjećuje se da lazura s organskim otapalima pokazuje grešku odvajanja od stanične stijenke (sl. 29) ili da nastaje kohezivski lom drvna oštećenog djelovanjem UV svjetla (sl. 30). Mjestimično se može vidjeti kombinacija ovih dviju grešaka (sl. 31). Vodotopljiva lazura vrlo rijetko iskazuje smanjenje prijanjanja o supstrat (sl. 32).
