# Comparison of Surface Quality and Tool-Life of Glulam Window Elements after Planing

### Original scientific paper • Izvorni znanstveni rad

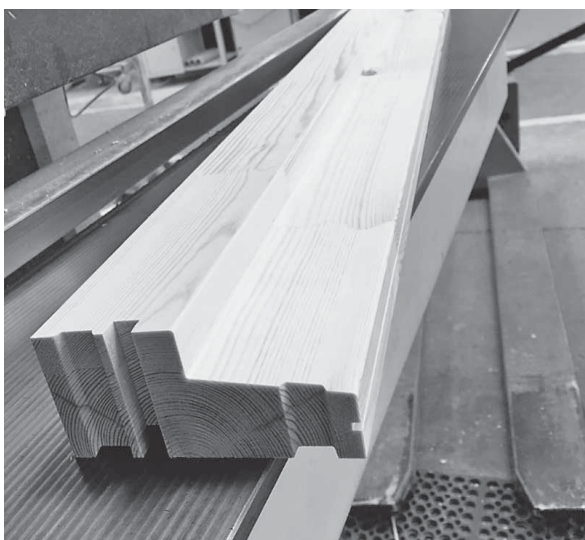
**Figure 2** View of the material after machining  
**Slika 2.** Izgled drvenoga lameliranog elementa nakon strojne obrade

ducted on the first out of three operations in the production process and was associated with shaping of the workpiece (Fig. 2).

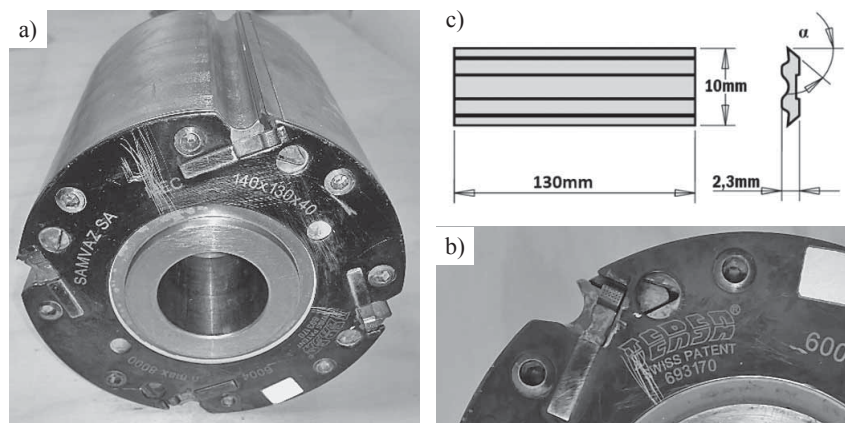
**Figure 3** General (a) and detailed (b) view of Tersa® system planer head of 140 mm in diameter and main dimensions of the blade (c) (Tersa, 2018)

In the research, a Tersa® system planer head was used of 140 mm in diameter (Fig. 3). The knife was made of the standard uncoated solid carbide (HW, K a group of application according to ISO (Tersa 2014)) of micrograin quality, and additionally for comparison blades were made of chrome steel (CR, HR13%Cr (Tersa 2014)). The knives are also characterised by clearance angles ( $\alpha$ ) in the knife-in-hand system equal to 50° (CR) and 35° (HW) (Tersa 2014). Moreover, the Tersa® system is characterised by great flexibility resulting from the system's modular design of identical aluminium washers.

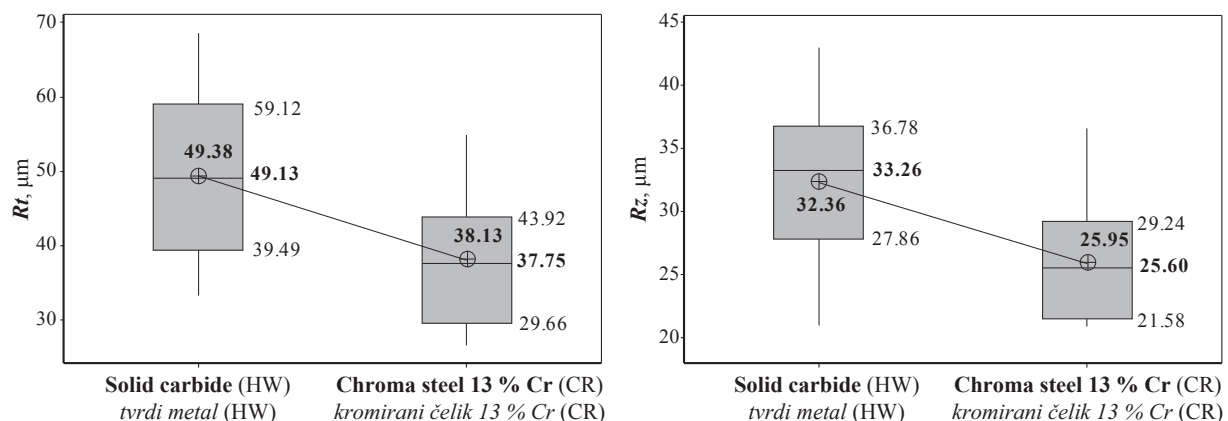
a) b)  
**Figure 6** The mean value and value dispersion of total height  $Rt$  (a) and maximum height  $Rz$  (b) of the profile vs. selected types of blade material (the box plot presents: the mean, median, interquartile range box and data range)  
**Slika 6.** Srednja vrijednost i rasipanje podataka: a) o ukupnoj visini  $Rt$  i b) o maksimalnoj visini  $Rz$  profila obrađene površine pri obradi dvama različitim noževima (na grafu su prikazane srednje vrijednosti, medijani, interkvartilni raspon i raspon podataka)

ond area (HW) and it was about 25 % greater than the maximum value for CR blade (Sample #6 second area). In both cases, the range of  $Rt$  parameter was significant and amounted to 33.31 – 68.54  $\mu\text{m}$  (HW) and 26.74 – 54.97  $\mu\text{m}$  (CR). Generally, mean and median were about 30 % greater for HW blade (Fig. 6). Similar situation occurred for maximum height of the profile ( $Rz$ ).

However, the inter-quartile range was 8.92  $\mu\text{m}$  (HW) and 7.66  $\mu\text{m}$  (CR), respectively, whereas these ranges were twice as high as parameter  $Rt$ . This indicates a greater concentration of results around the median, which is related to the method of determining this parameter based on a sampling length and not on an evaluation length as in the case of  $Rt$ .

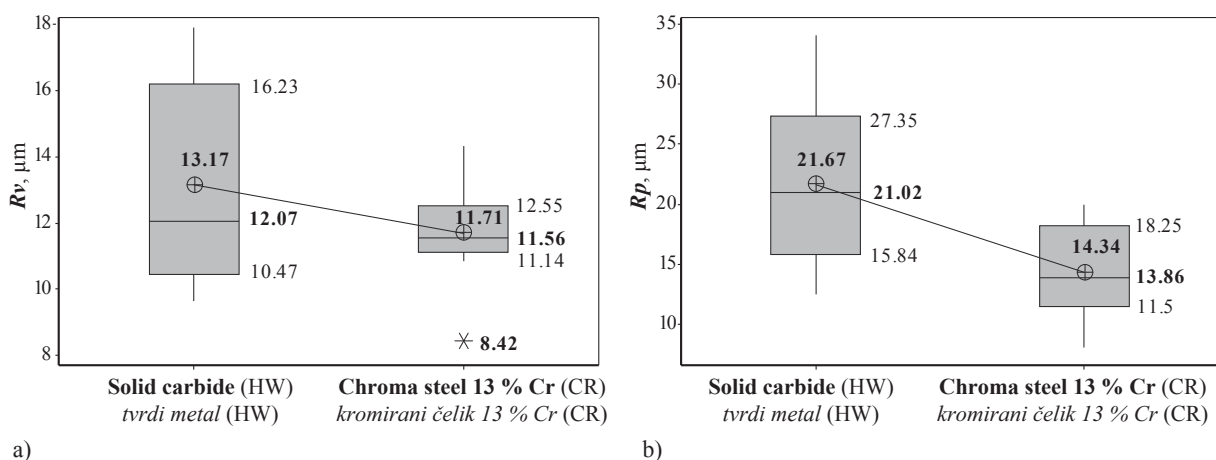
**Figure 8** The mean value and value dispersion of maximum profile: valley depth  $Rv$  (a) and peak height  $Rp$  (b) vs. selected types of blade material (the box plot presents: the mean, median, interquartile range box and data range - outlier)  
**Slika 8.** Srednja vrijednost i rasipanje podataka: a) o dubini udoline  $Rv$  i b) o visini vrha  $Rp$  maksimalnog profila površine obrađene dvama različitim noževima (na grafu su prikazane srednje vrijednosti, medijani, interkvartilni raspon i raspon podataka)

In both cases in question, the means and medians of maximum profile valley depth ( $Rv$ ) were on similar level, whereas in case of maximum profile peak height ( $Rp$ ), the difference between them was about 7  $\mu\text{m}$  (Fig. 8). The maximum values of  $Rv$  and  $Rp$  were 20 % and 40 % greater for HW blades, respectively. The range of the quartile box for HW blades was nearly two times higher than for CR blades. Likewise, the dispersion of measured values was doubled. However, the consideration of 8.42  $\mu\text{m}$  outliers leads to the conclusion that ranges of  $Rv$  can be comparable.

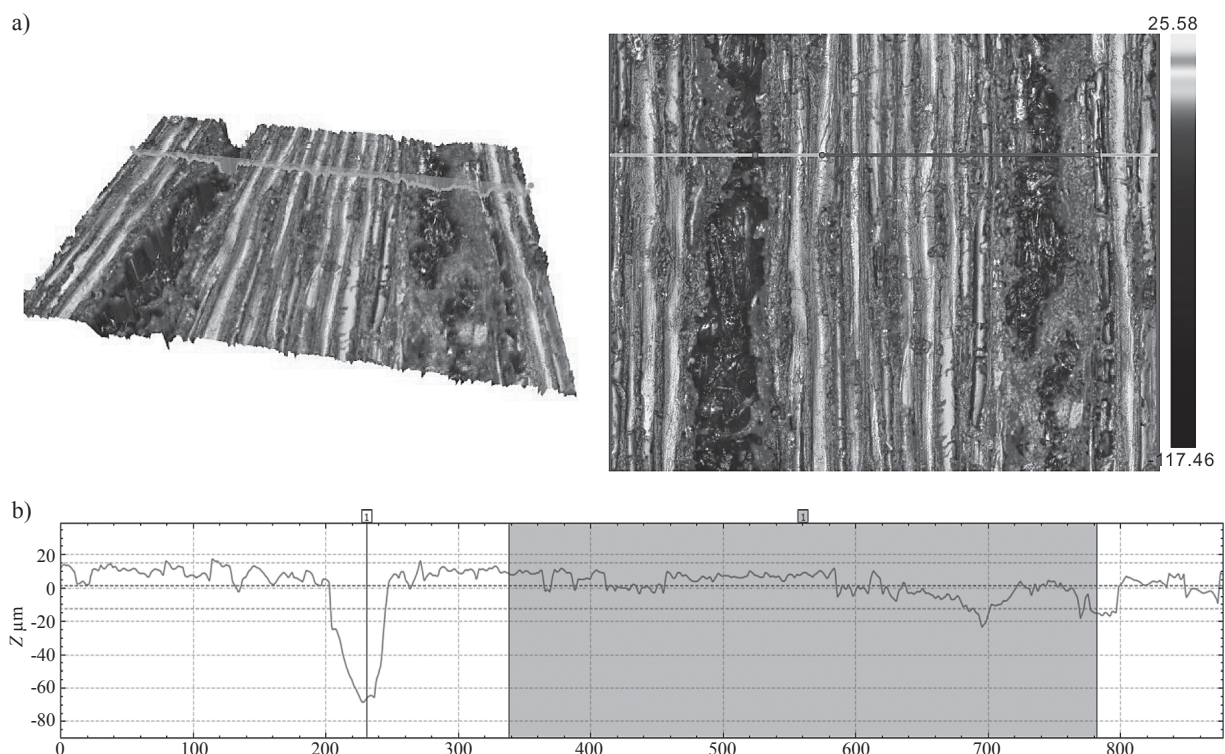
**Figure 9** 3D surface topography (a) and 2D profile (b) of the 2<sup>nd</sup> test sample  
**Slika 9.** a) 3D topografija površine, b) 2D profil drugoga ispitnog uzorka

For a more detailed analysis of the damage to the surface, some 3D measurements of the surface condition were made with 3D Optical Profiler S Neox (f. Sensofar 2017) (Fig. 9 and 10). Moreover, the 3D measurements have given a complete image of the surface condition as a critical element of the entire machining process. The obtained results are in agreement with findings by Zongh *et al.* (2013). The results of selected 3D surface texture parameters are shown in Table. 5.

Since deep scratches are the key factor for surface quality before painting, their  $\Delta Z$  heights were established (Table 5). This height ( $\Delta Z$ ) was calculated as a height between the points (if there is 1 extreme value – Samples #1 ÷ #4 – pink line, Fig. 9b) or central point of the mean line (if there are more extreme values – Samples #5 and #6 – pink area, Fig.10b) and central point of the mean line of the plateau (pink areas). For the above points, the angle A (Table 5), which gives the information about distance between them, was also determined. Height ( $\Delta Z$ ) and maximum pit depth ( $Sv$ ) in Sample #1, #3 and #4 were comparable, while differences among the remaining samples were significant. In the case of Sample #5 and Sample #6, the  $\Delta Z$  parameter was even 2.5 times smaller, meaning that height of the deep valley was smaller than  $Sv$  suggested. It should be emphasised that 3D surface texture parameters (ISO), together with additional parameters, are essential for defining irregular surface features.
