Performance of thermally modified timber (TMT) in outdoor application – durability, abrasion and optical appearance

Original scientific paper · Izvorni znanstveni rad

ABSTRACT • Thermally modified timber (TMT) is increasingly offered in Europe as an alternative to preservative treated timber. TMT durability in field tests as well as its moisture sorption behaviour in façade application was determined so as to consider its suitability for outdoor use. Additionally, abrasion and crack-formation of TMT deckings were examined and the optical appearance of a TMT façade was evaluated after 5 years of service. After 7.5 years exposure in ground contact, the various TMT materials tested were classed as “slightly durable” to “not durable” whereas the classification in above ground exposure was “very durable” to “moderately durable”, which was in line with the reduced moisture sorption of TMT in weathered application. Moreover, the TMT-decking showed less abrasion and crack-formation compared to references, though the TMT façade revealed considerable discoloration by weathering. Hence, the suitability of TMT for above ground use is suggested, but a surface treatment is obligatory if discol

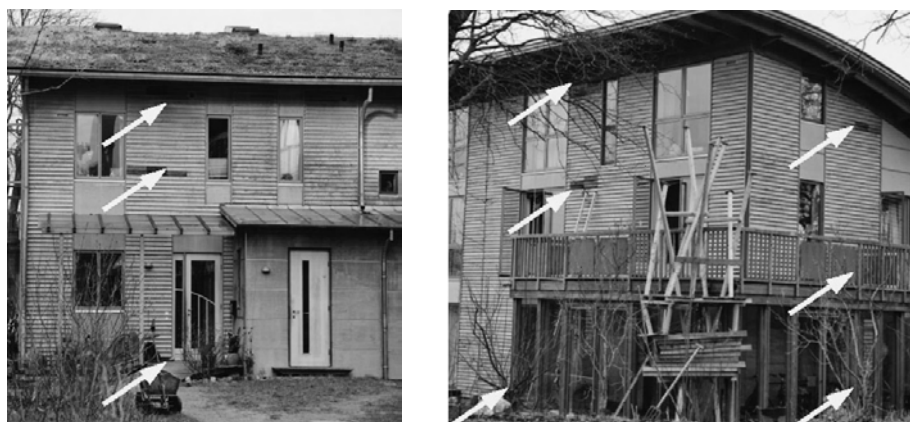
Figure 1 East and South-West orientation of the house facade in Kiel; Arrows point to the location of TMT boards with glued-in electrodes for long-term moisture recording

Determination of moisture behaviour in weathered application was performed with boards of 500x122x22 mm³ from European larch heartwood (*Larix decidua* Mill.), Scots pine sapwood (*Pinus sylvestris* L.), Norway spruce sapwood (*Picea abies* Karst.) and Oil-Heat-treated spruce sapwood (220°C, 1h). These materials (*n*=9) were mounted with stainless screws as weather boarding on a house façade in East, West and South orientation in Kiel, North-Germany, in 9 different locations in the year 2000 (Figure 1).

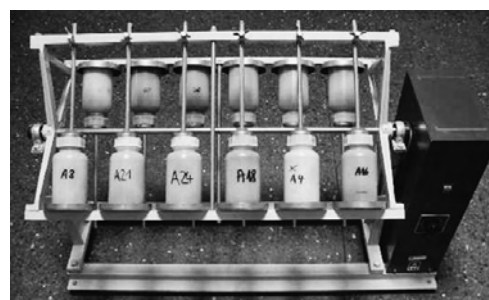
Figure 2 Polyethylene flask, steel balls, specimens and over-head shaker used in Shaker-tests

The resistance to abrasion after the Shaker-method was determined as follows: 5 specimens of 35x10x10 mm³ were oven dried, weighed and put into a polyethylene flask of 0.5 l together with 400 g of steel balls of 6 mm diameter (Figure 2). The filled flasks were put in an overhead shaker and rotated with 28 min⁻¹ for 72 hours. Afterwards, the specimens were cleansed of wood dust by air pressure, oven dried and weighed again to determine the abrasion in terms of mass loss. Five specimens were weighed together and gave one replicate, ten replicates were used.

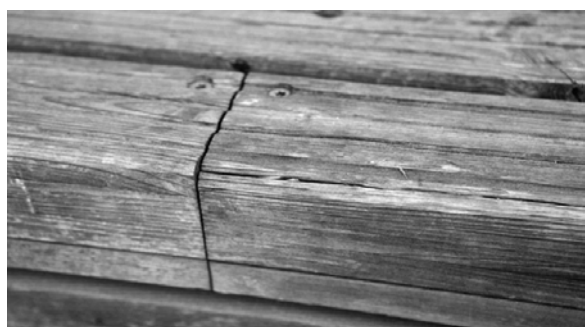
Figure 7 Rounding of edges and break ups of TMT-gluelam in service

No remarkable formation of cracks by weathering or occurrence of flake offs was found, which points to the decreased dimensional changes of the façade due to reduced sorption of TMT. In contrast, the accessible TMT-gluelam apron showed substantial wear, caused by rounding of edges and break ups of the edges (Figure 7).
